**Engineer Reactors Group  
Corps of Engineers  
United States Army**

**Report OSB 15**

**Preliminary  
Investigation of SM-1 Control  
Rod Seal Failure**

18 April 1961

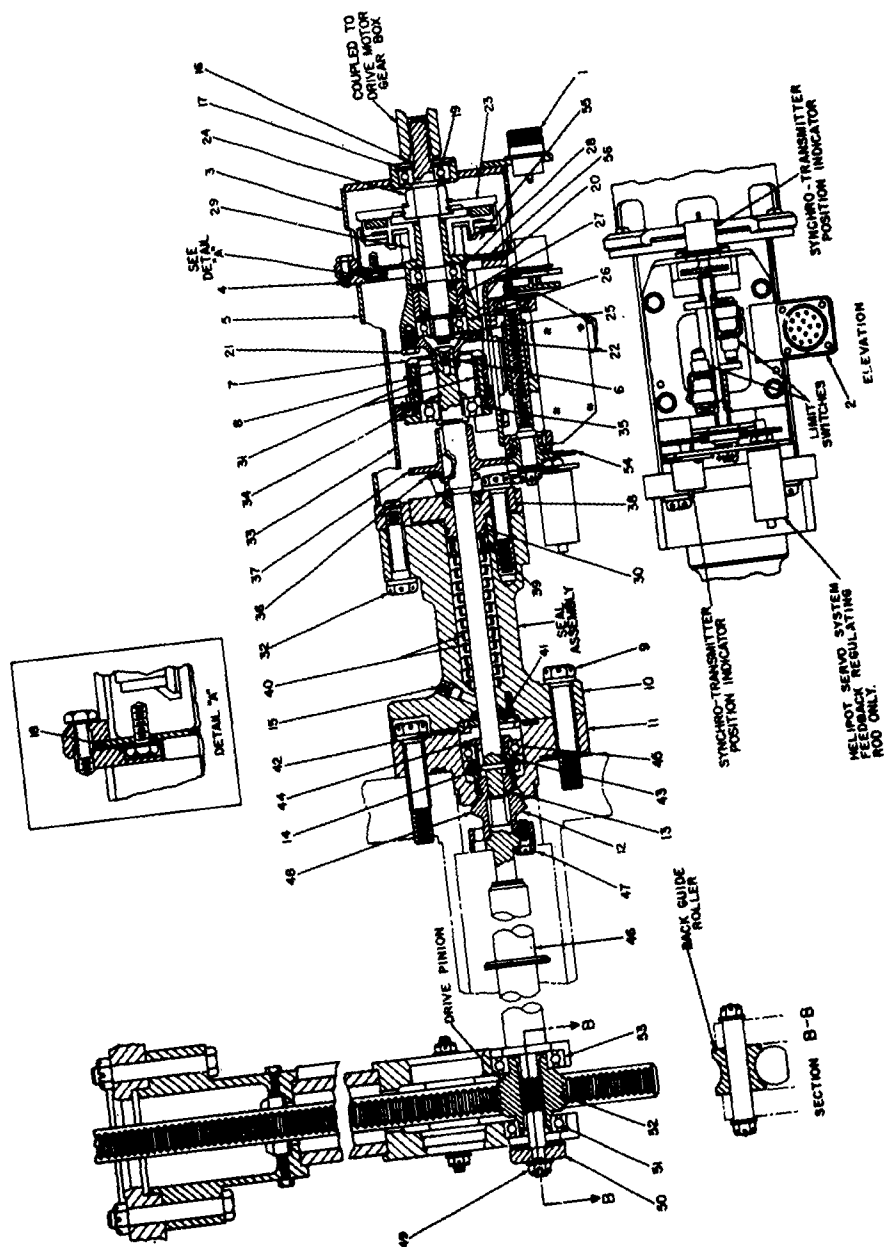
Figure 1

One area which deserves some further evaluation is the failure of the outboard bearing (35-Fig 1)

Control Rod and Drive Mechanism

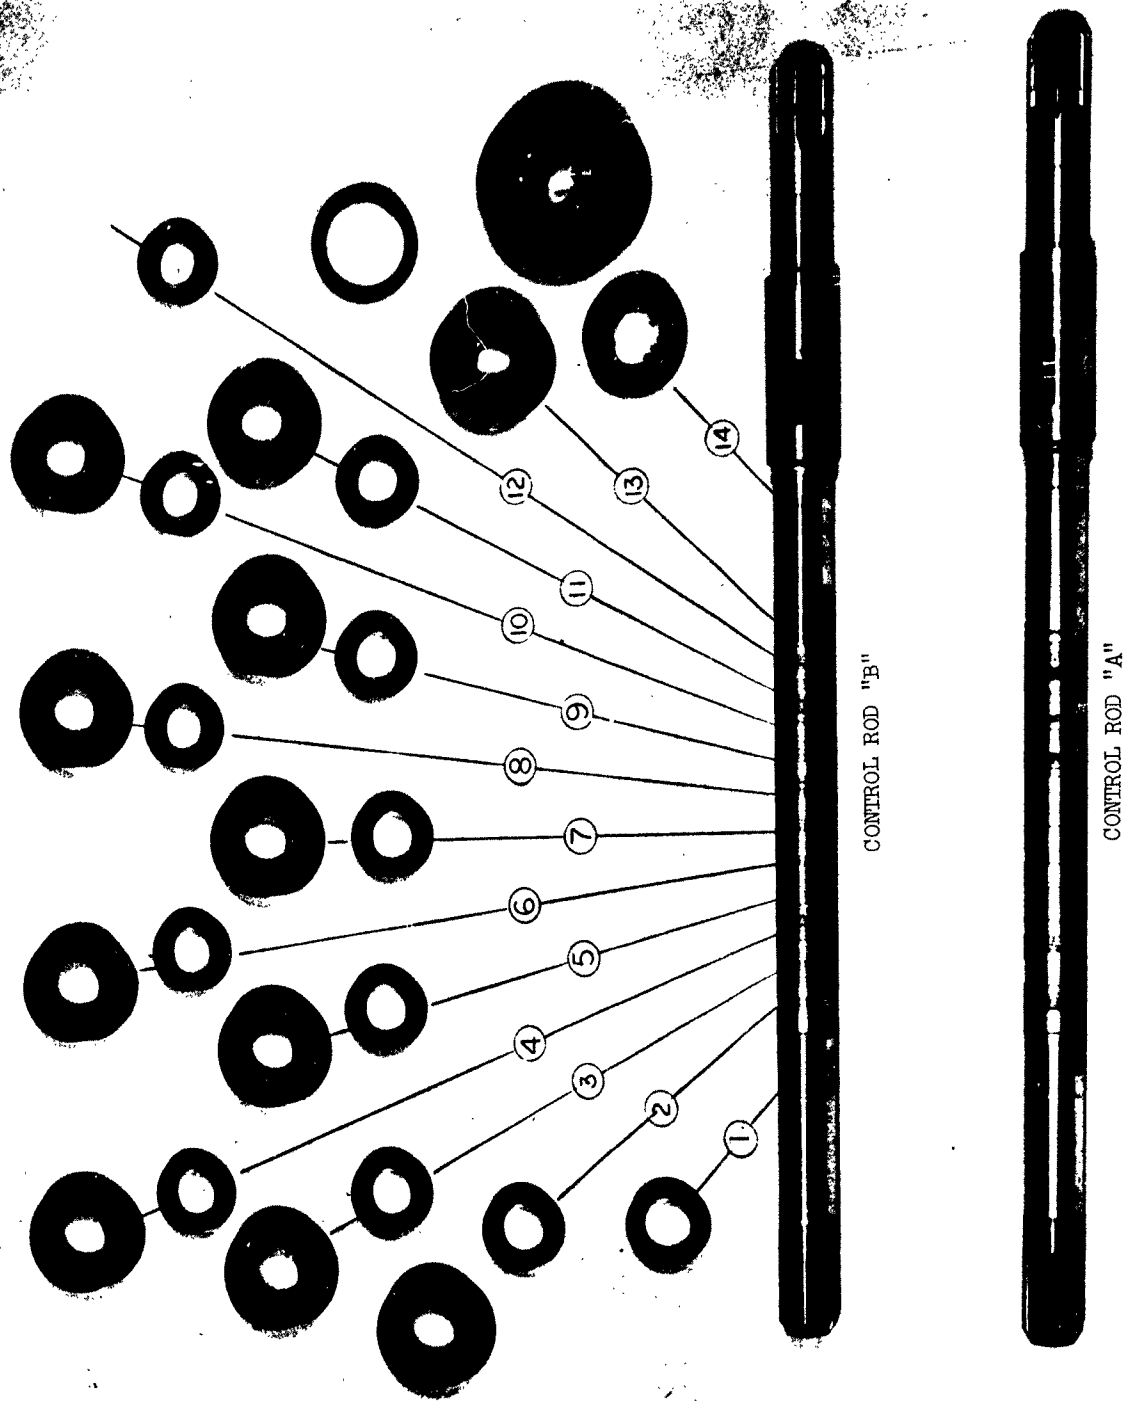
through them. Photographs were taken of the parts and are shown in figures 2, 3, 4, 5, 6, 7, and 8. Figure 2 shows the contact surfaces of the seal rings and where applicable the diaphragm with which they come in contact. Figures 3, 4, 5, and 6 show close-ups of the two seal shafts in the area where the seal rings and diaphragms are in contact. The four figures show the four quadrants of the shafts. They were rotated 90° clockwise looking from the driven end which contains the Woodruff key. The upper shaft in all pictures is that belonging to the various parts shown and was used to control Safety Rod "B". The lower shaft came from the assembly which drove Safety Rod "A".

The defects believed to be blistering and cracking (Fig 7 and 8) of the chrome plating at seal ring locations 10 and 11 (Fig 2) could conceivably be caused by overheating. It may be possible that useful life would have been longer if the chrome plating had not been used. It was noticed that the seal rings were only worn on the outboard side where the thrust forced them to ride against the contact surface on the diaphragm as designed. Figures 7 and 8 show close-ups of these surfaces. It should be noted that on most seal ring faces there is a groove corroded into the seal ring concentric with the contact surface which is believed to contain crud. There was no obvious wear on the seal ring inside diameter, although some is expected.

Fig. 2. SM-1 Worn Control Rod Seal Components

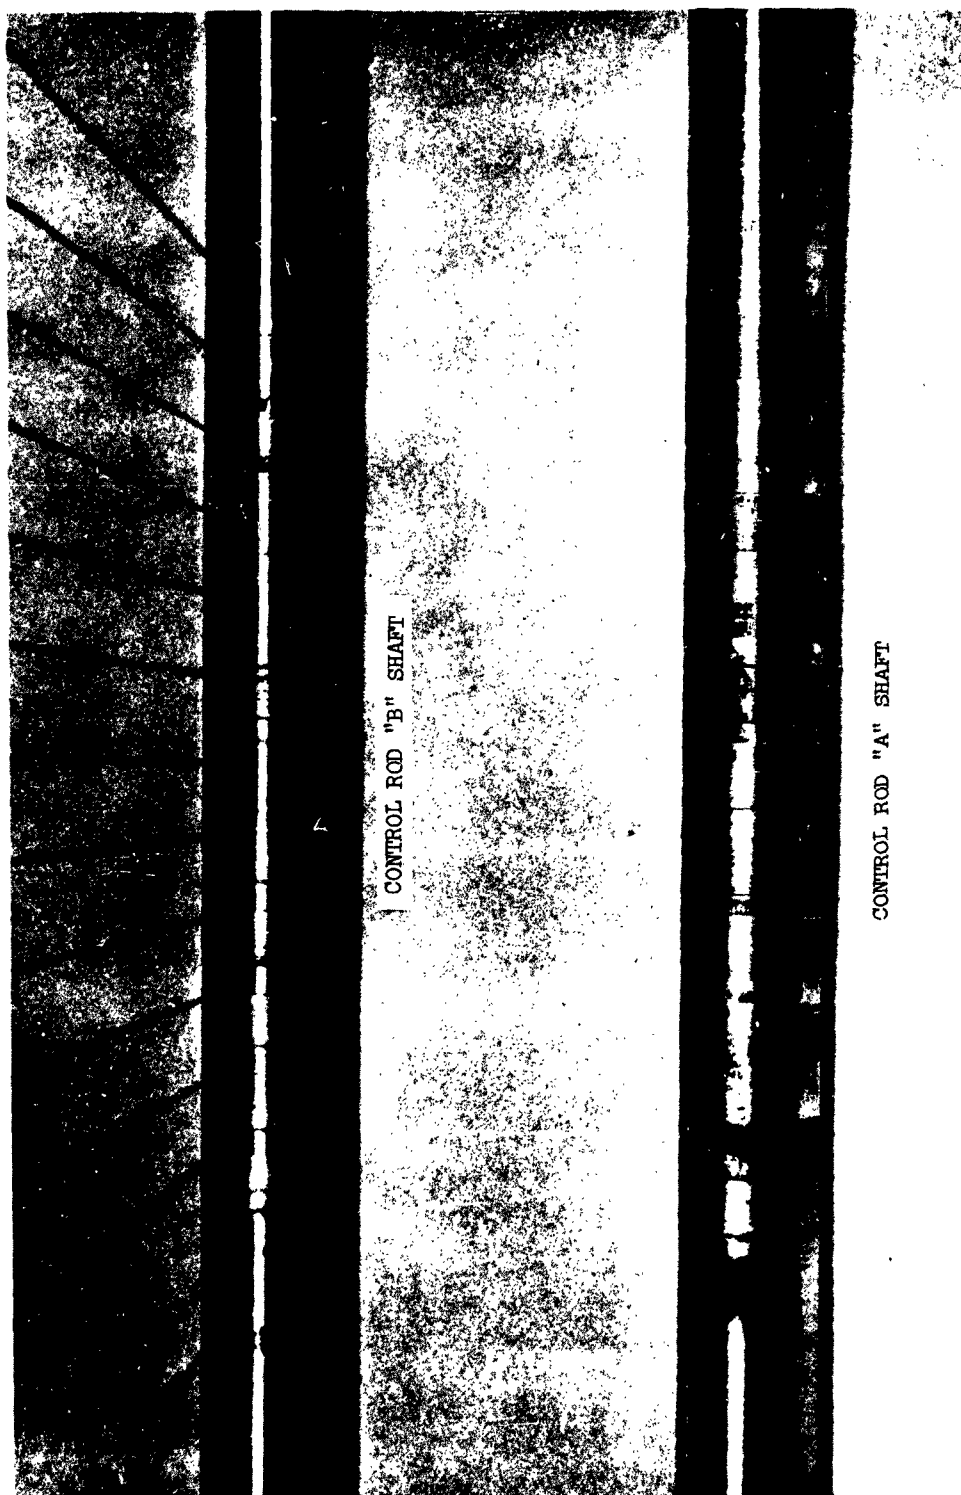
The wear on the shaft and diaphragm would indicate that the seal rings rotate rather than float as designed. Since the seal rings slide over the shaft easily, it would be expected that overheating by loss of cooling water to the seals at various times during the 4 yr operating life of the seals caused the rotation of the seal ring due to lack of lubricating water and decreased clearance.

Fig. 4. Quadrant II - SM-1 Control Rods A & B Shafts

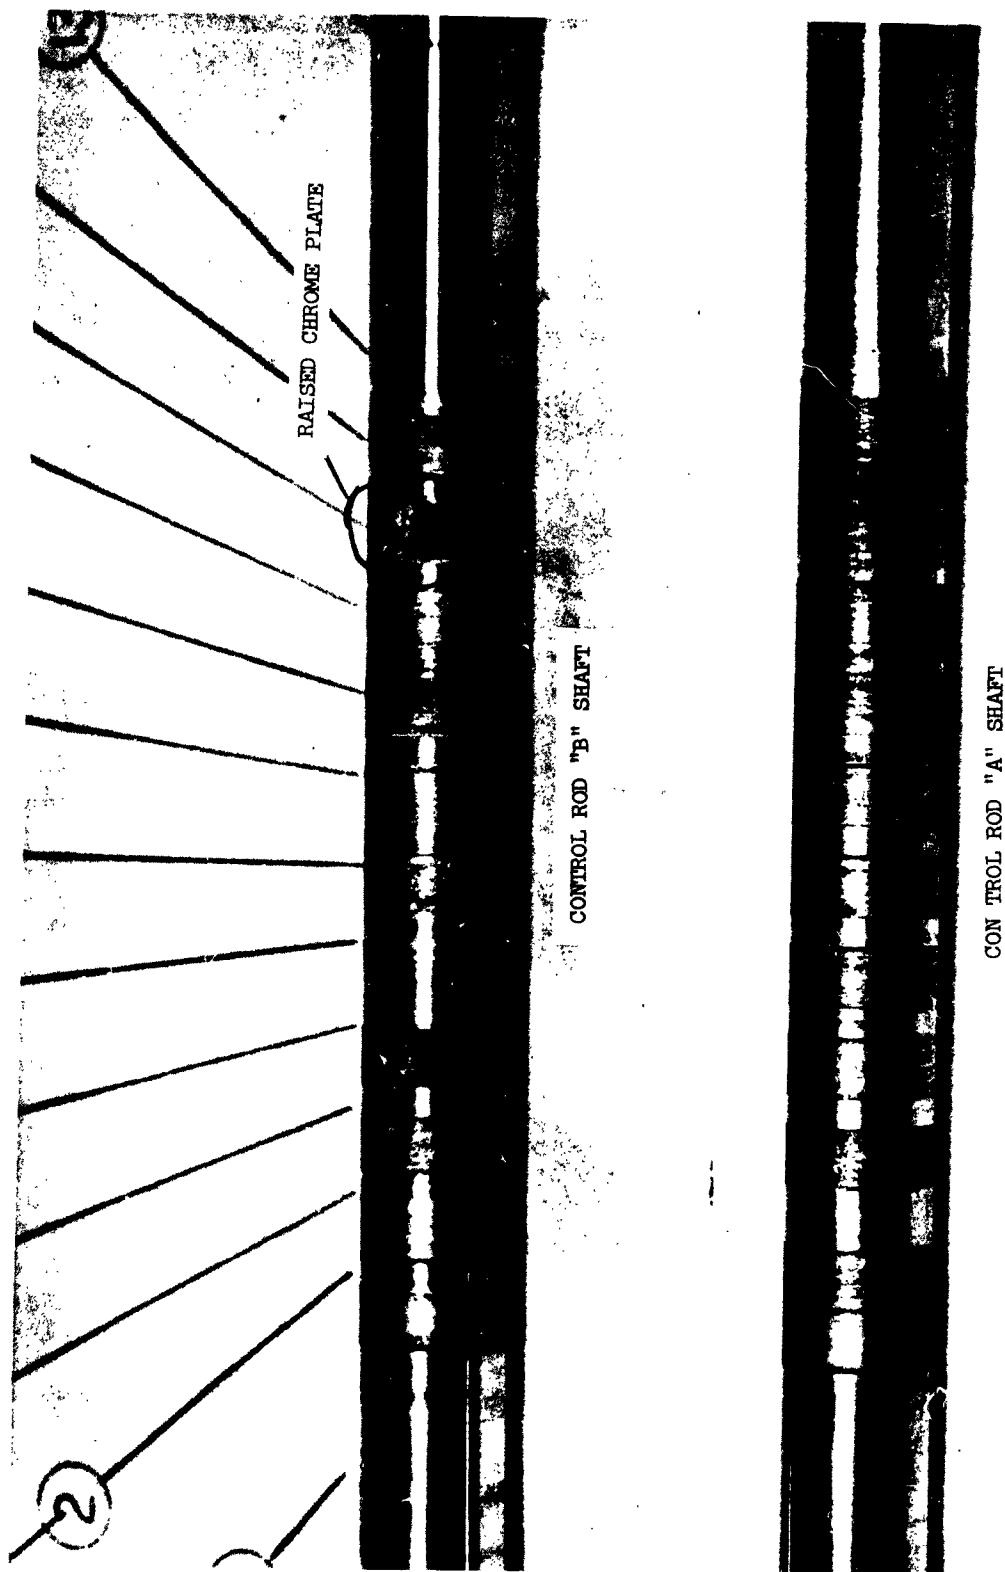
Fig. 6. Quadrant IV - SM-1 Control Rods "A" & "B" Shafts

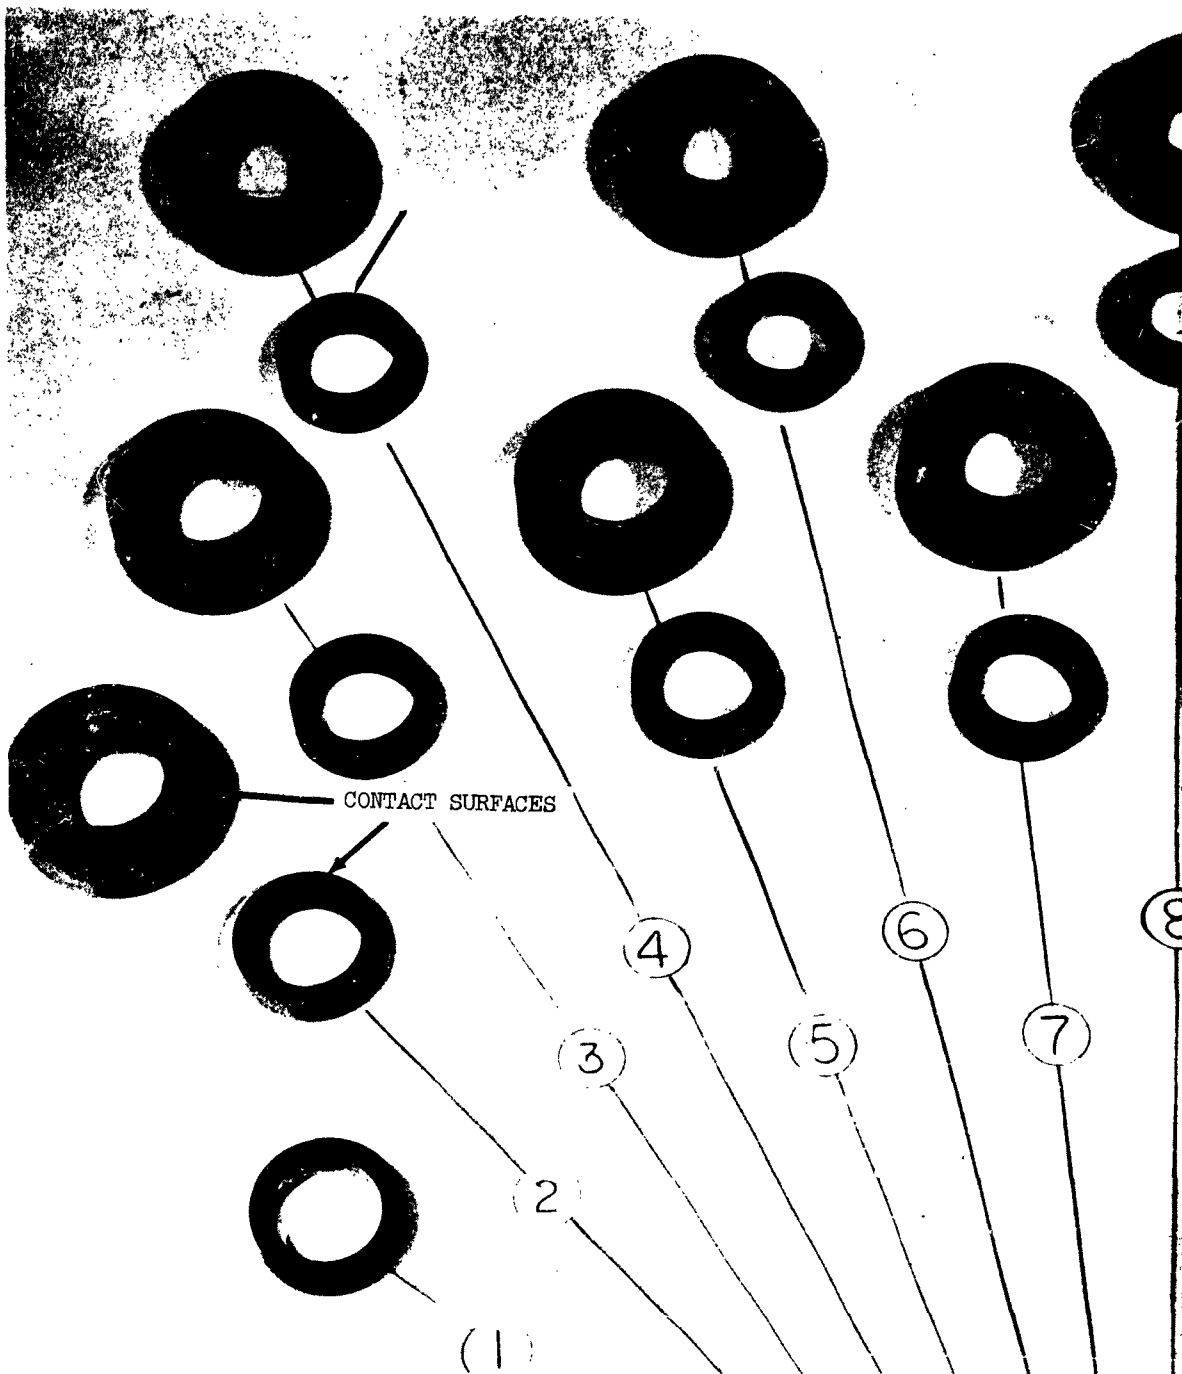
Fig. 7. SM-1 Seal Rings & Diaphragms of Control Rod Seal "B" (1)

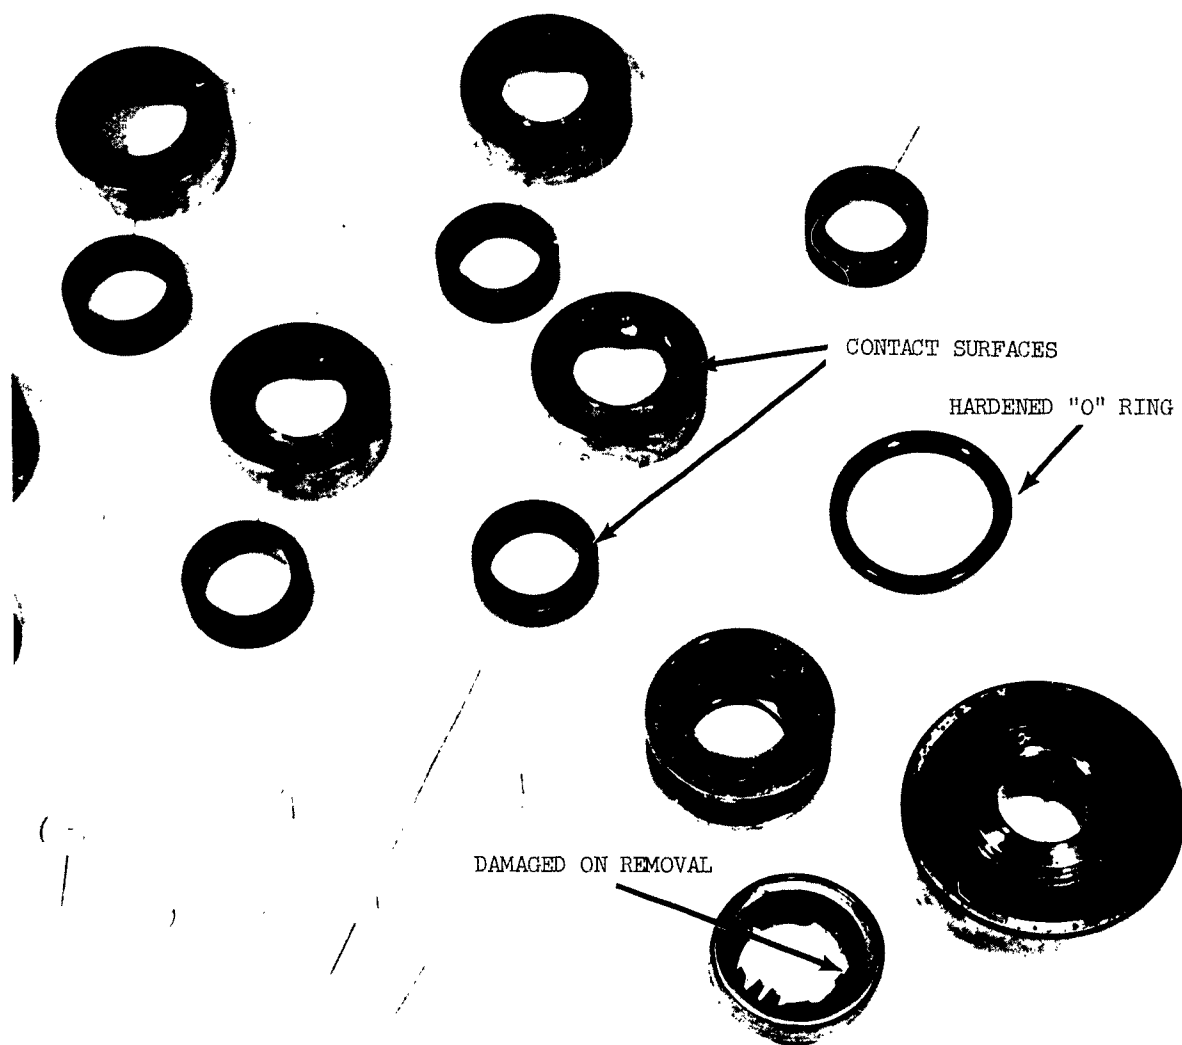
Fig. 8. SM-1 Seal Rings & Diaphragms of Control Rod Seal "B" (2)
